**BAKERSFIELD CITY SCHOOL DISTRICT  
ROOSEVELT ELEMENTARY SCHOOL MODERNIZATION  
BAKERSFIELD, KERN COUNTY, CALIFORNIA**

**ADDENDUM NO. #02**

**NOTICE TO CONTRACTORS FIGURING THIS WORK**

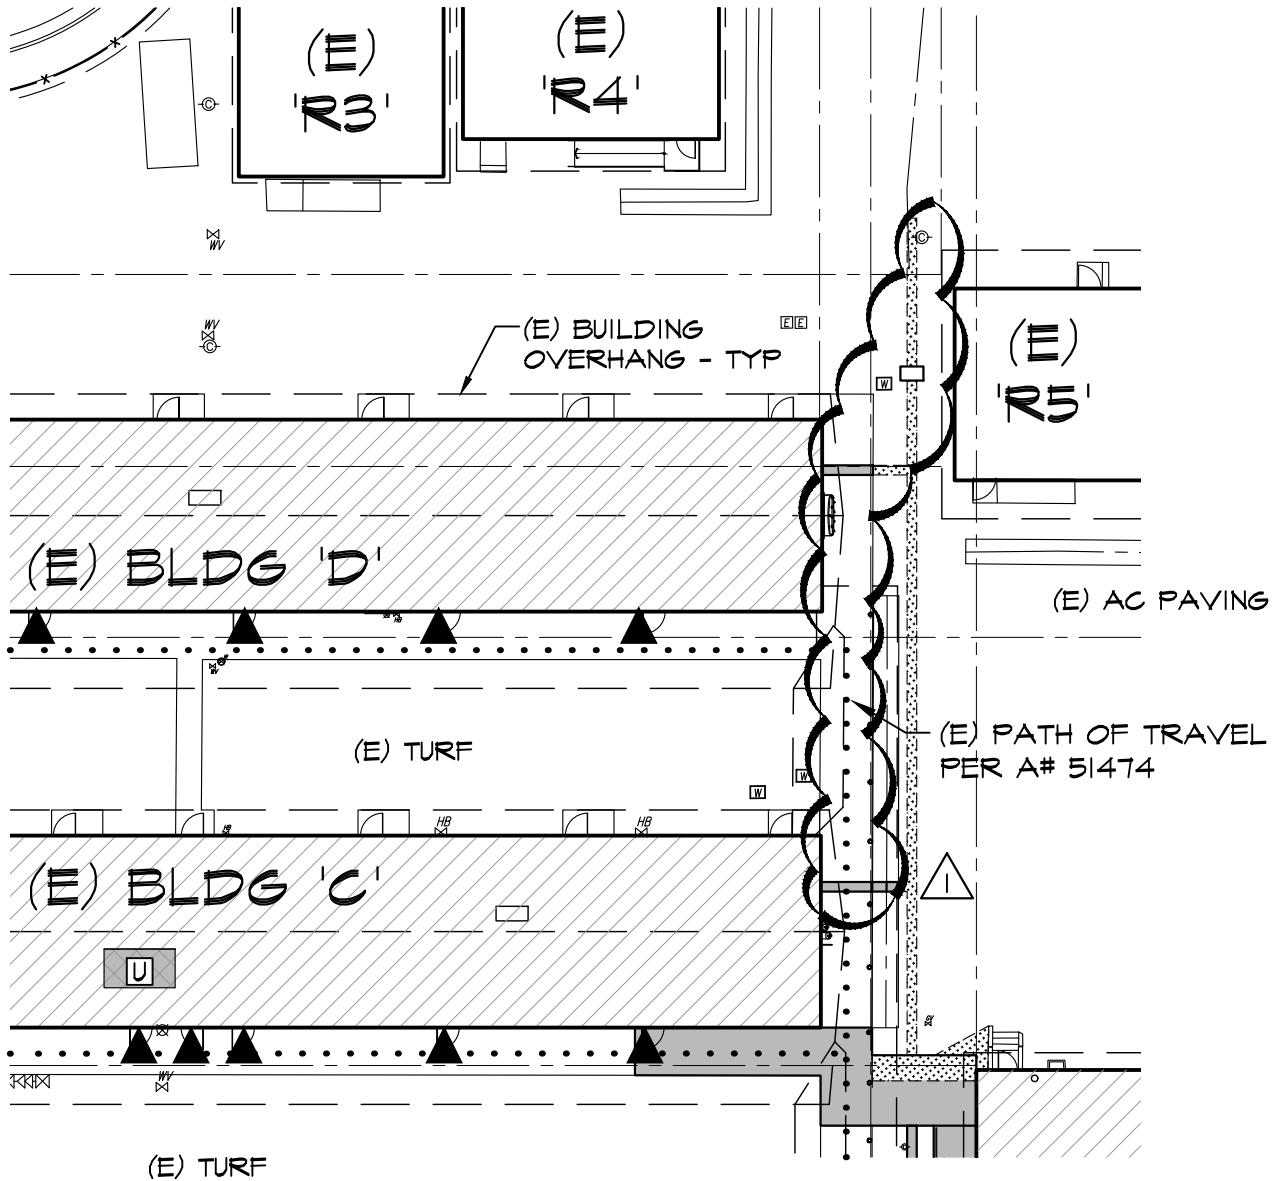
ITEM • 2-6a

- a. REVISE: Trenching on East side of Buildings C & D for conduit run from Panel “PC” to Panel “PD” to be as per attached Drawing Nos. 01 and 02.
  - b. ADD: Note – District will cap any irrigation as required, Contractor to repair any irrigation lines damaged by Contractor during course of construction by their personnel.

△ REVISING TRENCH FOR  
ELECTRICAL CONDUIT

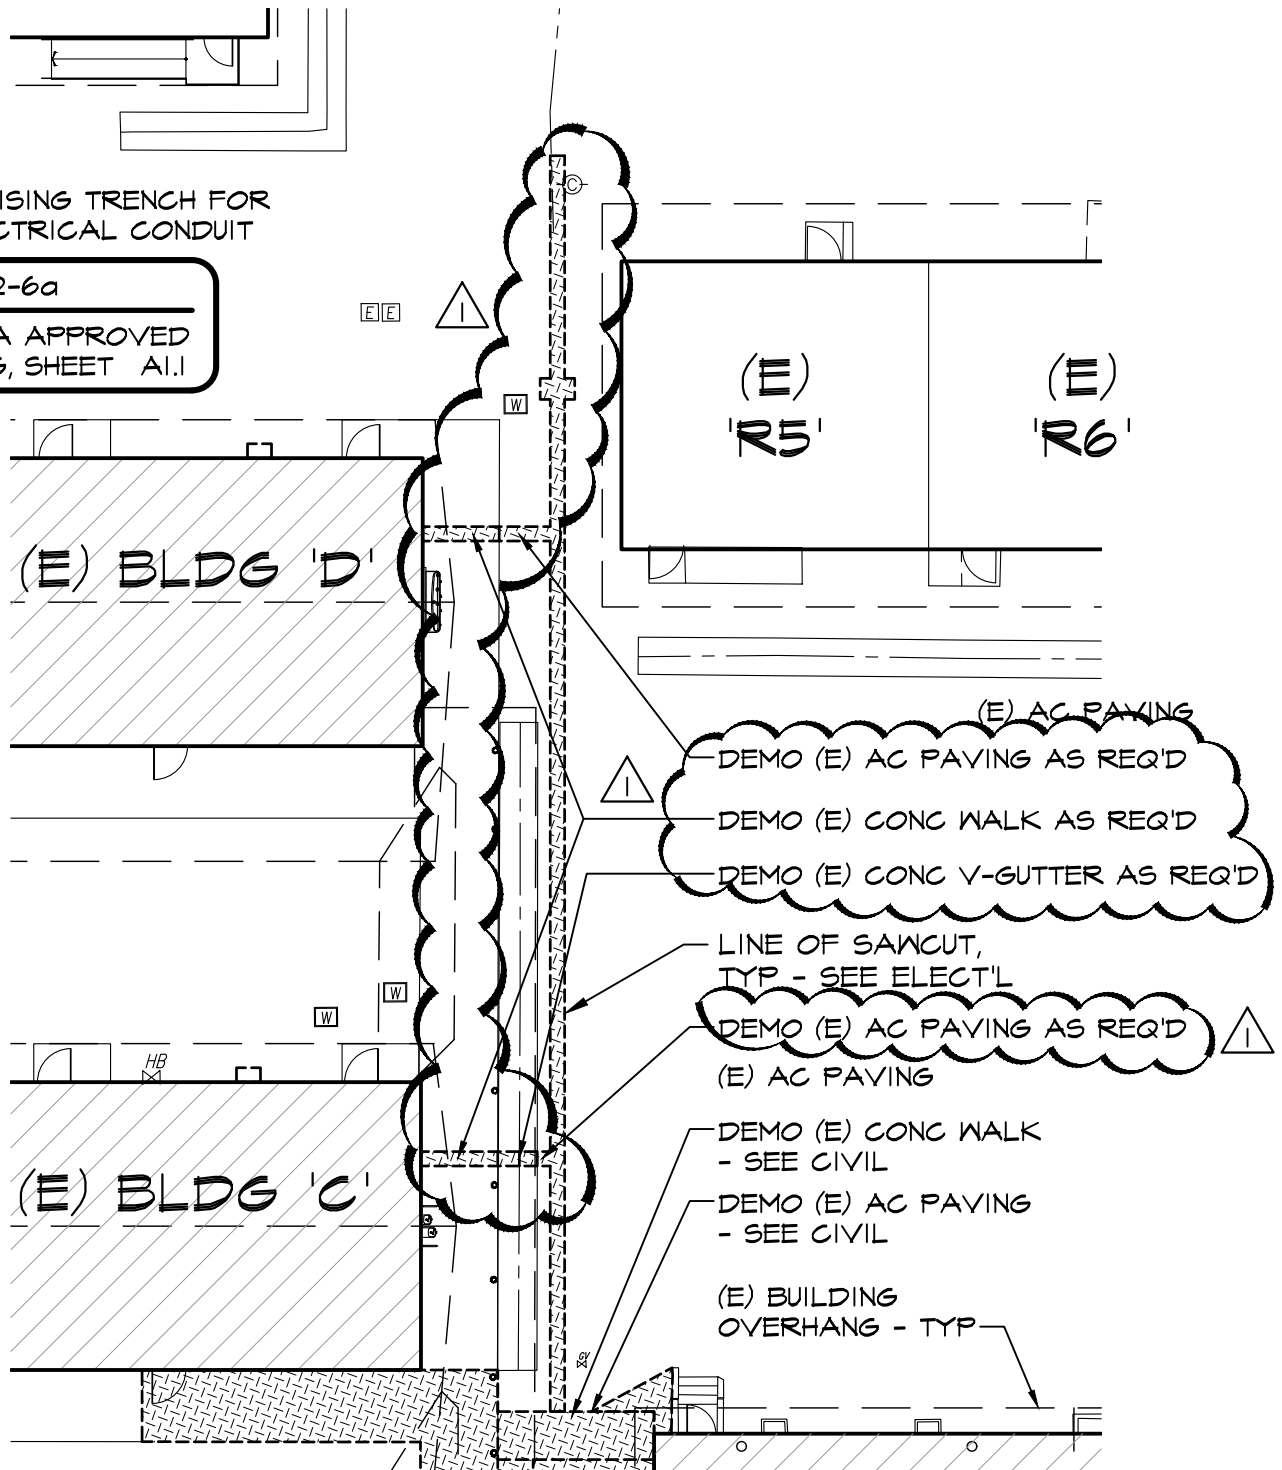
# PARTIAL DEMO SITE PLAN

REF. DSA APPROVED  
DRAWING, SHEET A1.1

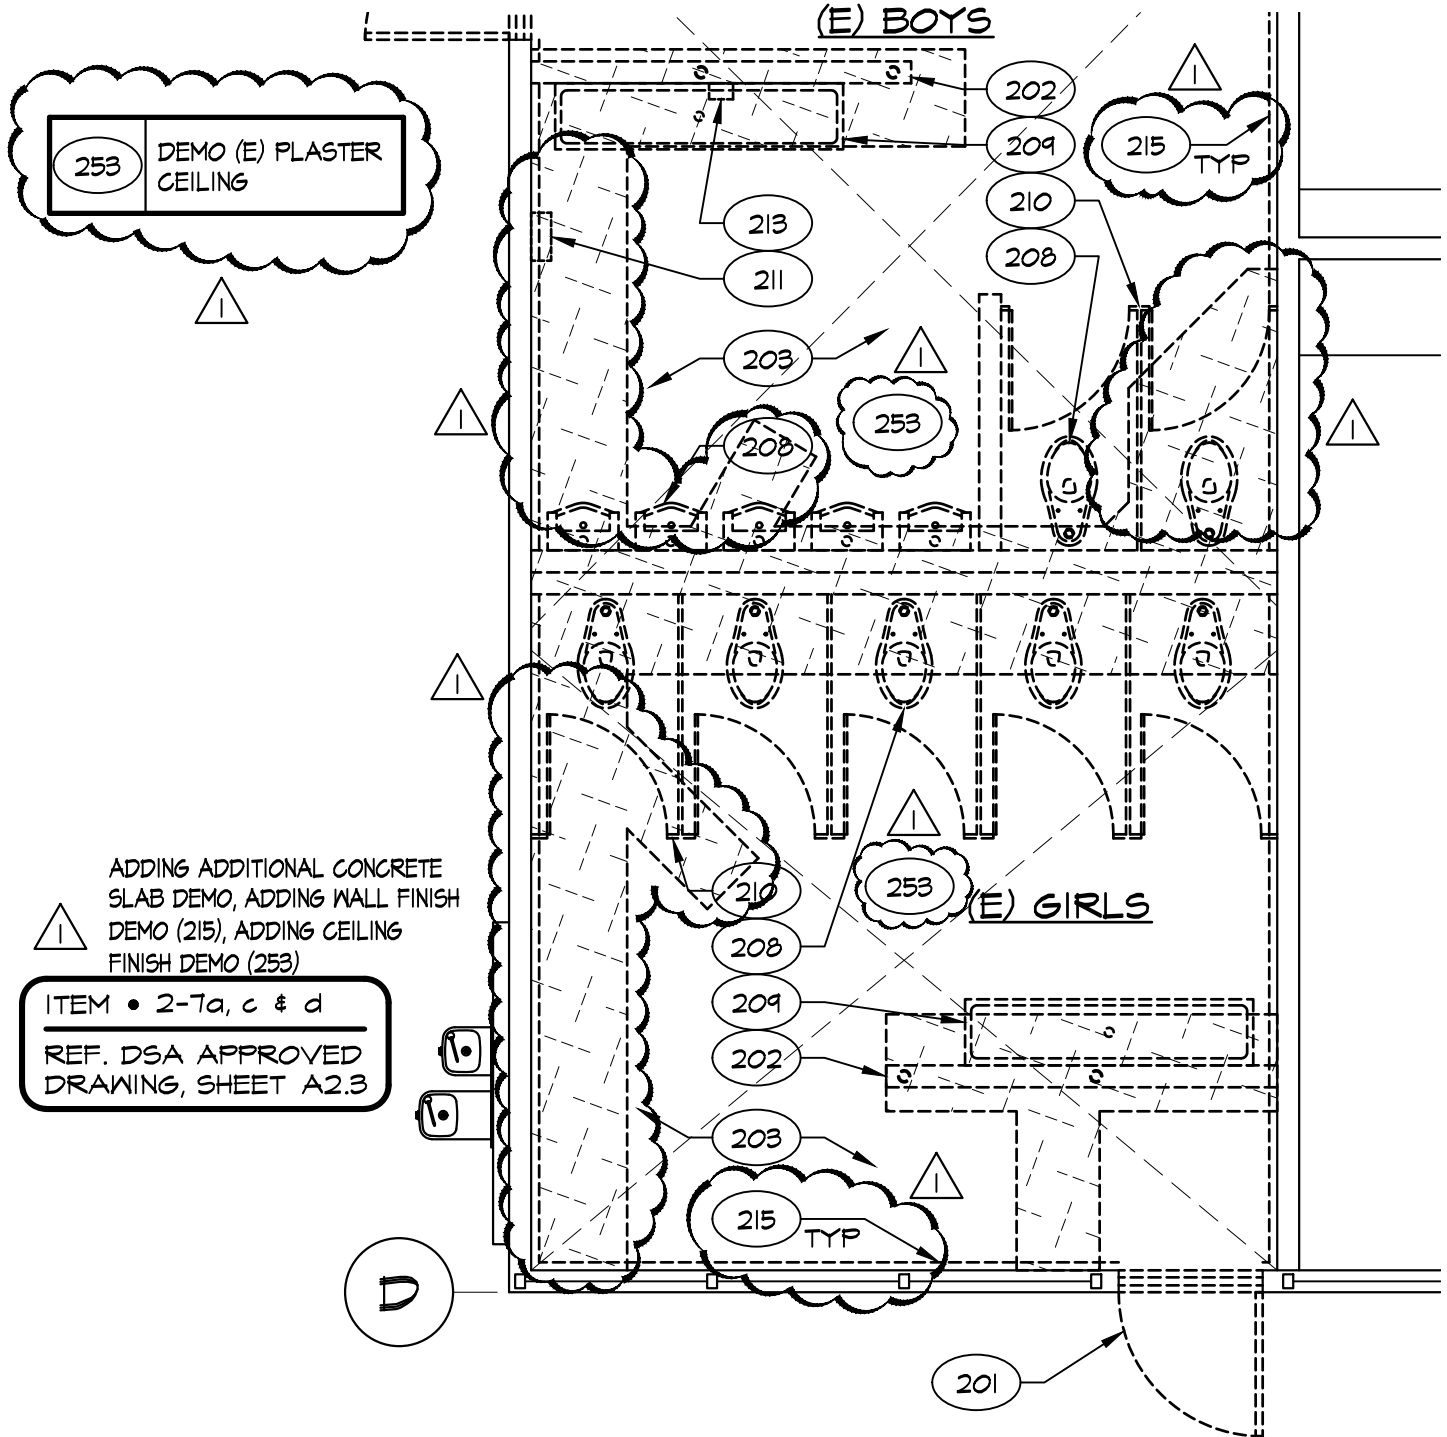
# PARTIAL DEMO FLOOR PLAN

- 2-7) Refer to DSA Approved Drawings, Sheet No. A2.3 FLOOR PLAN BUILDING “D”, PARTIAL FLOOR PLAN & DEMO PLAN, ROOMS 401 BOYS & 402 GIRLS;
- a. REVISE: Concrete slab demo and replacement as indicated per attached Drawing Nos. 03 and 04.

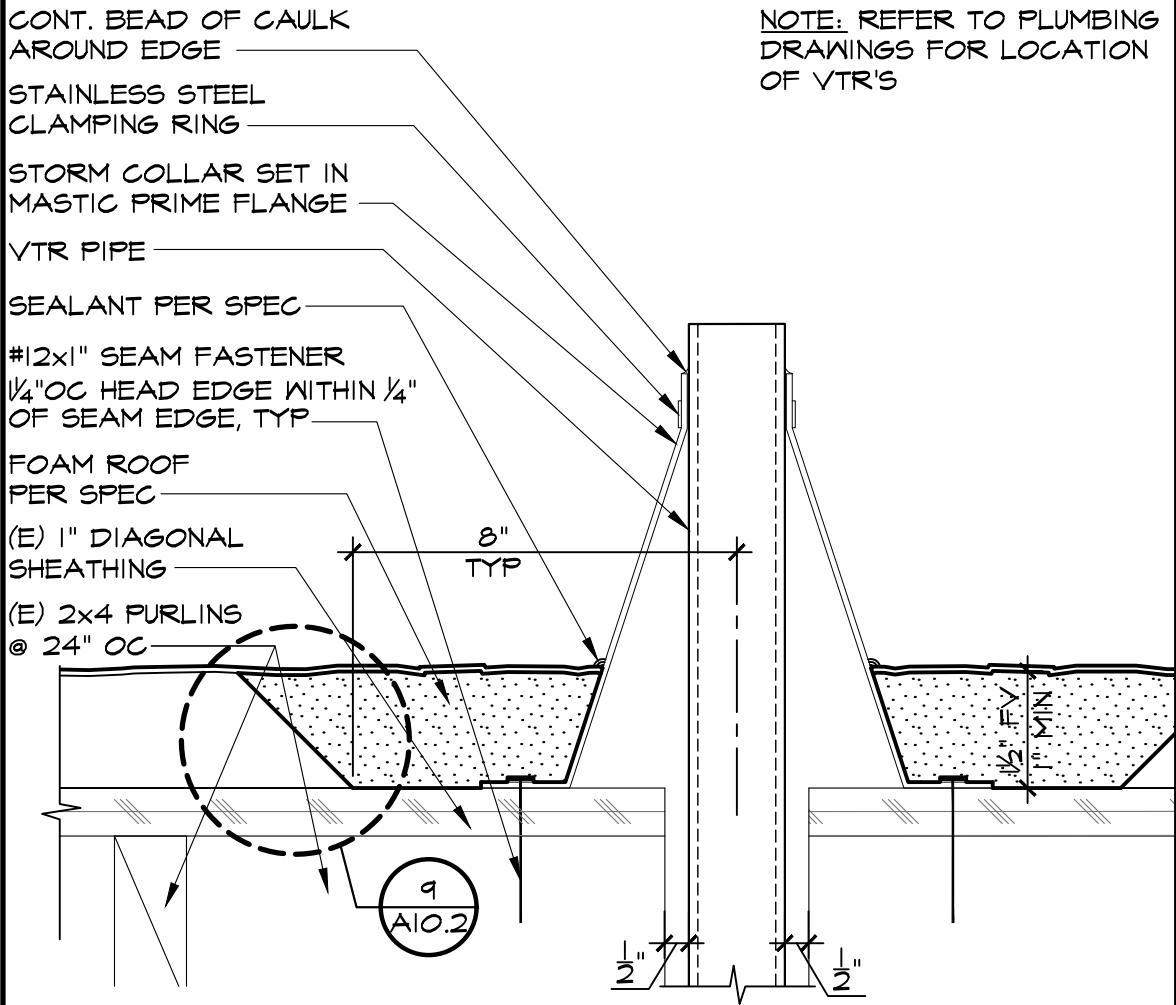
2

STAINLESS STEEL  
CLAMPING RING

(E) 2x4 PURLINS  
@ 24" OC

NOTE: REFER TO PLUMBING  
DRAWINGS FOR LOCATION  
OF VTR'S

PIPE BOOT FLASHING @ ROOFING SCALE: 3"=1'-0"

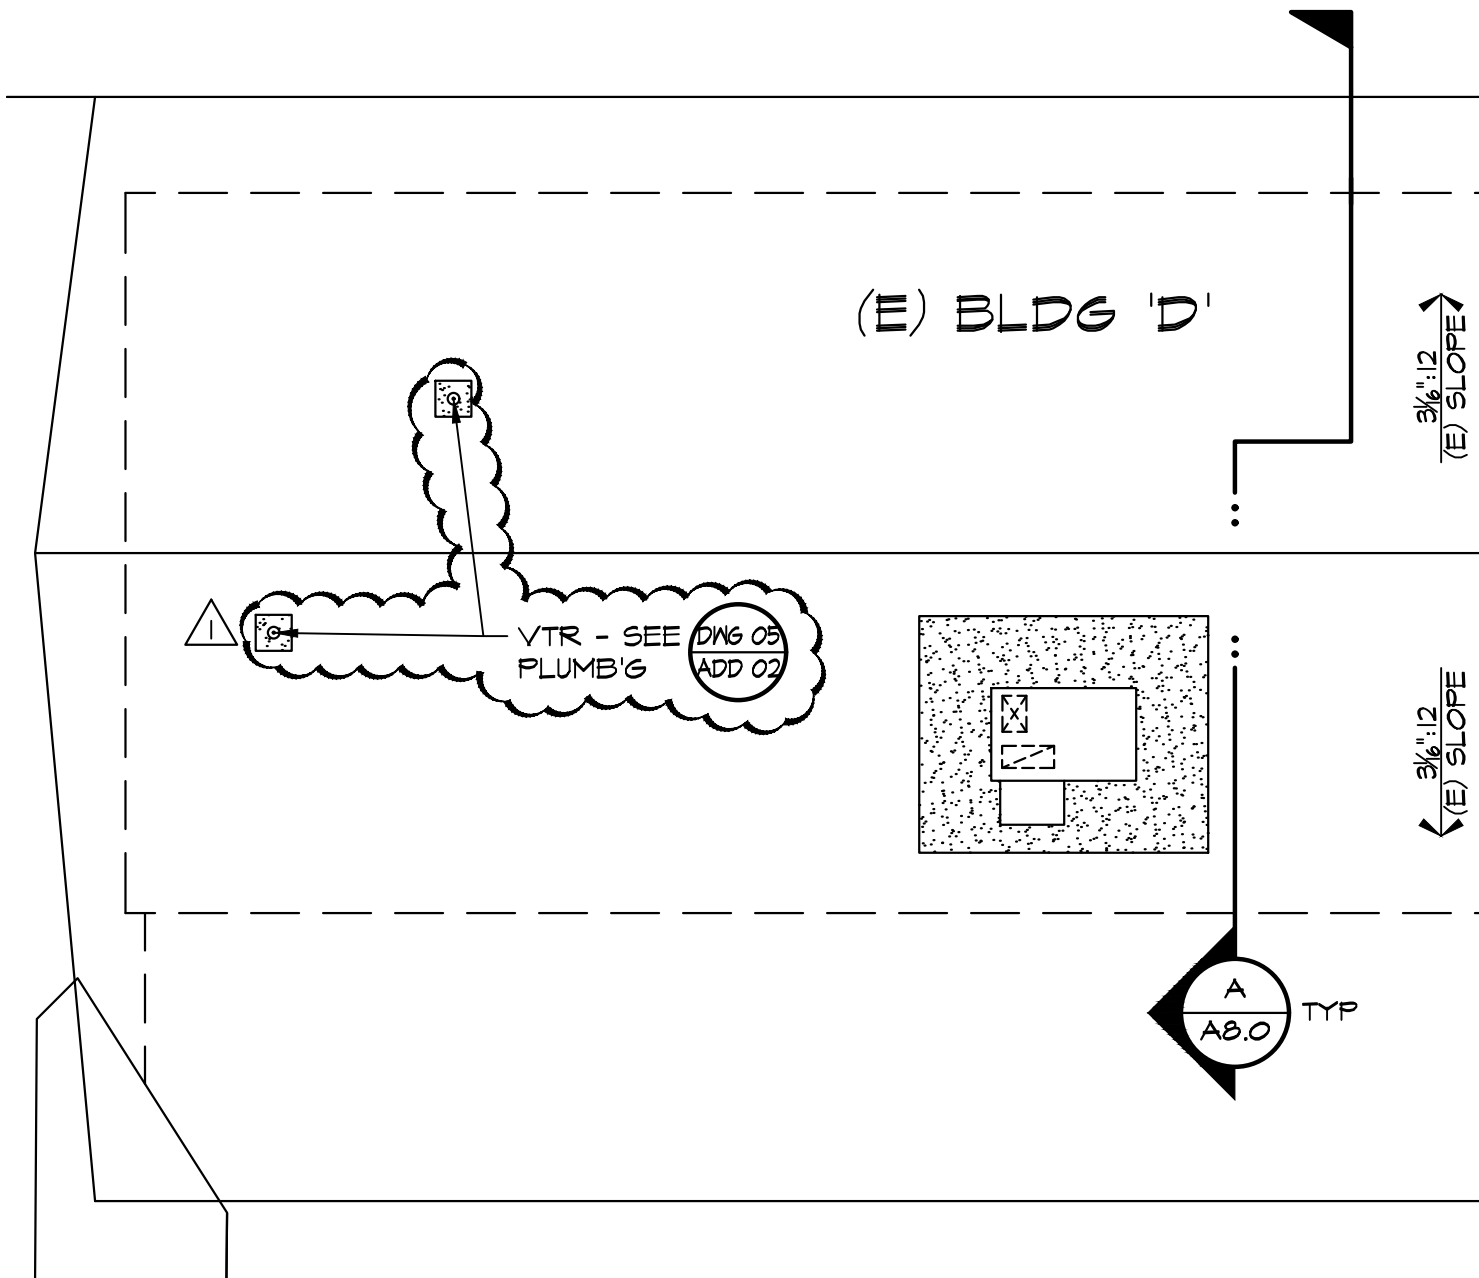
ITEM • 2-13a

△ ADDING VTR'S

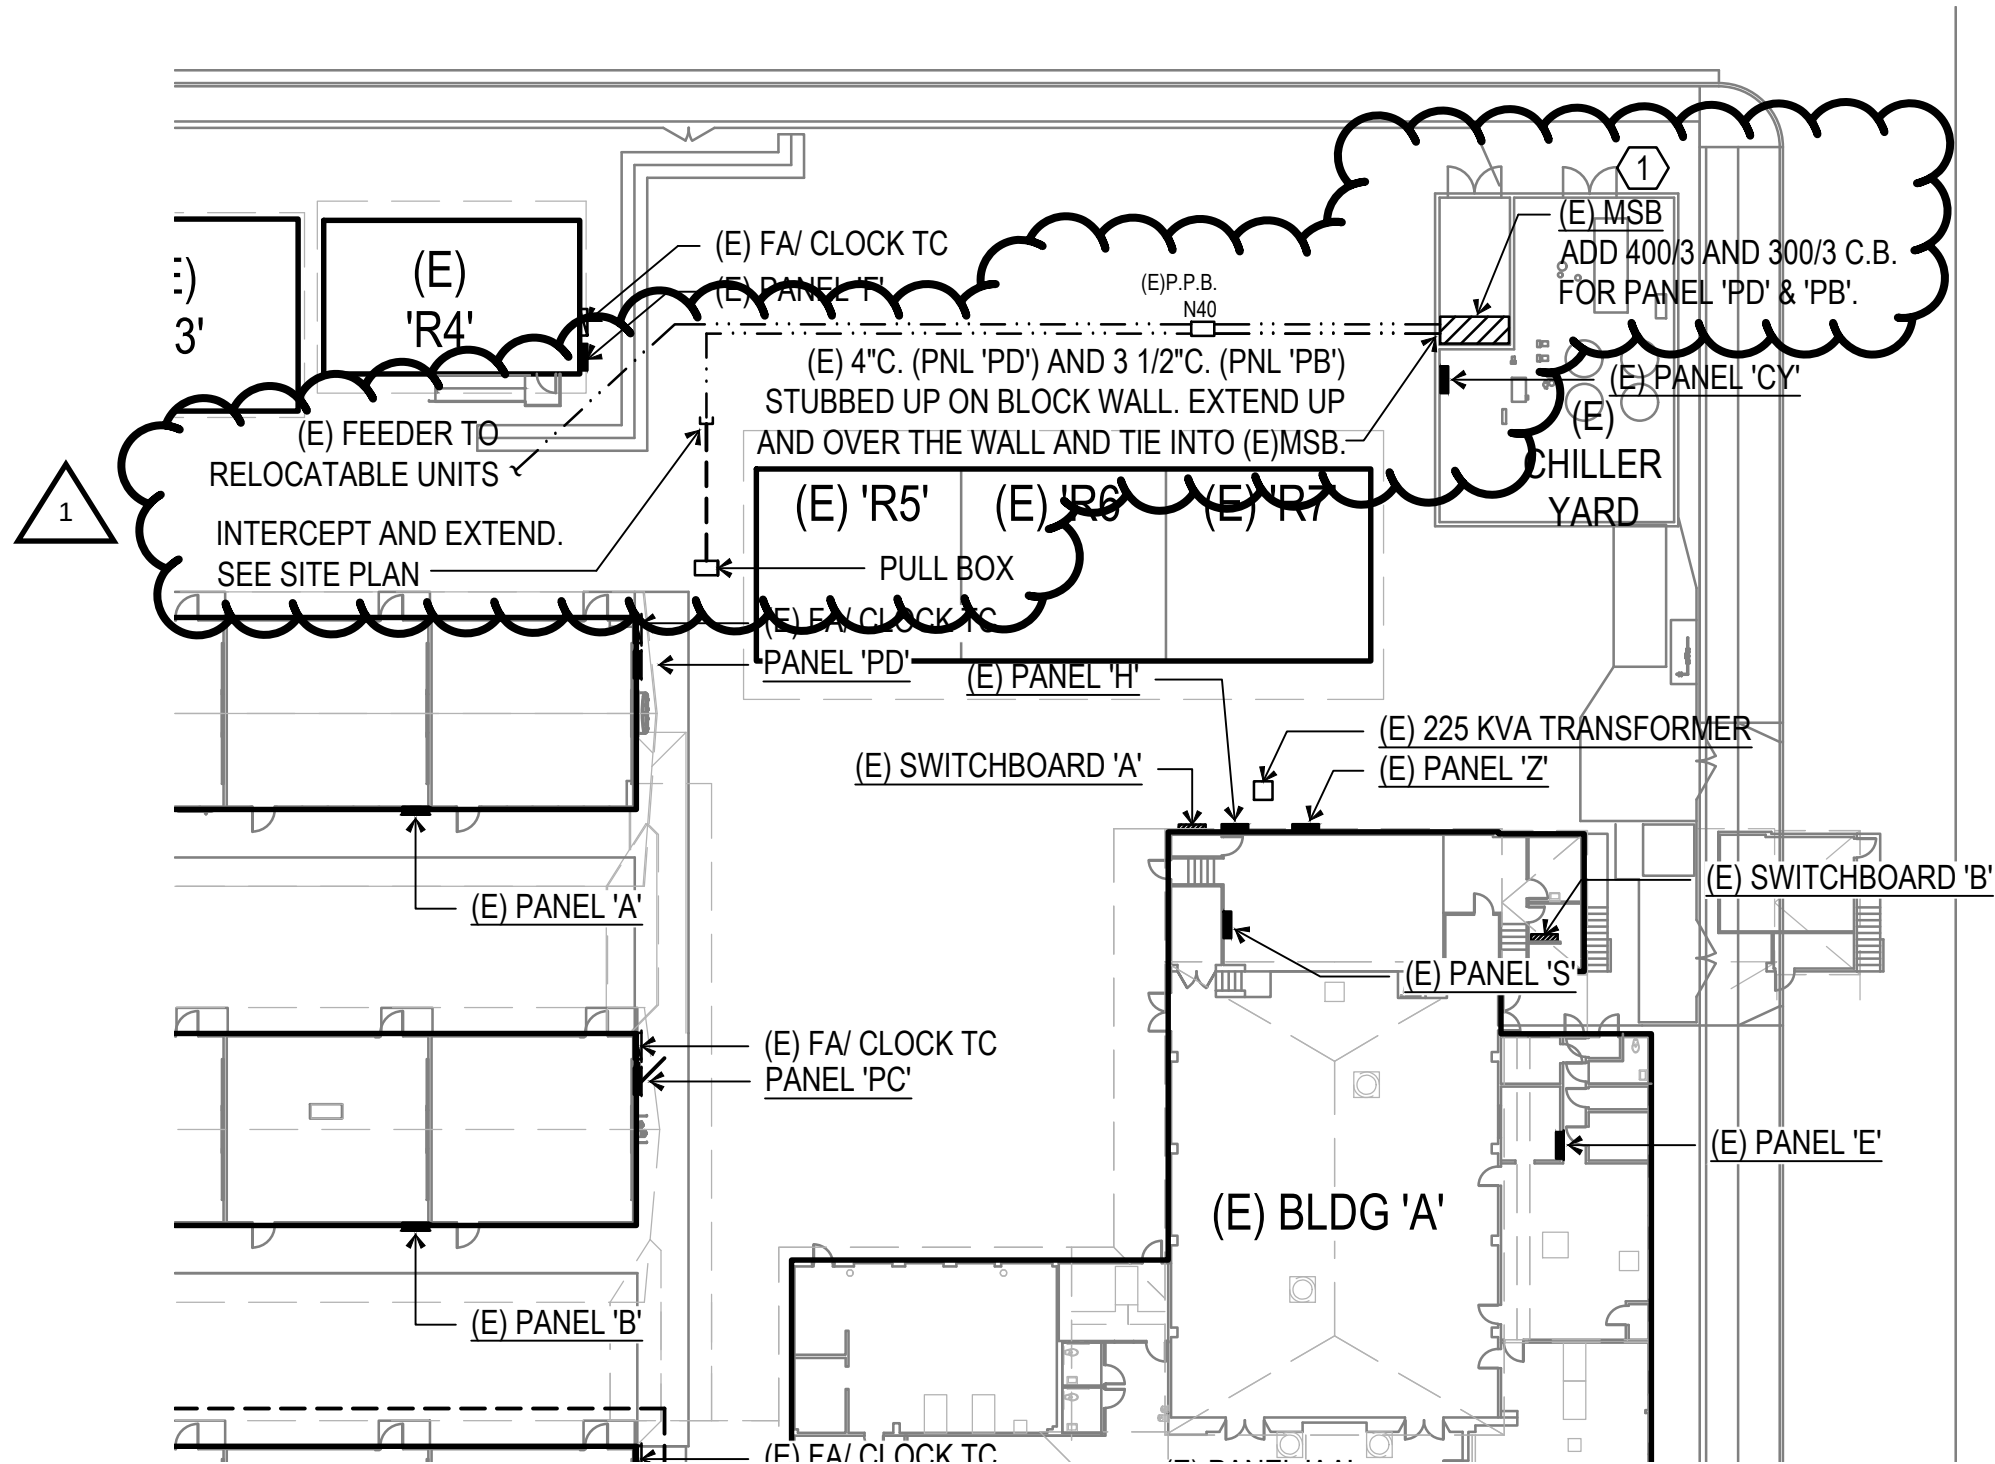
## REFERENCE NOTES

- 1 EXISTING MSB TO BE REPLACED SUMMER OF 2025. DISCONNECT TEMPORARY PANEL 'PD' AND 'PB' FEEDERS. INTERCEPT AND EXTEND 4" C AND 3 1/2" C FROM EXISTING N40 P.B. BORE UNDER EXISTING BLOCK WALL FOOTING TO NEW MSB.

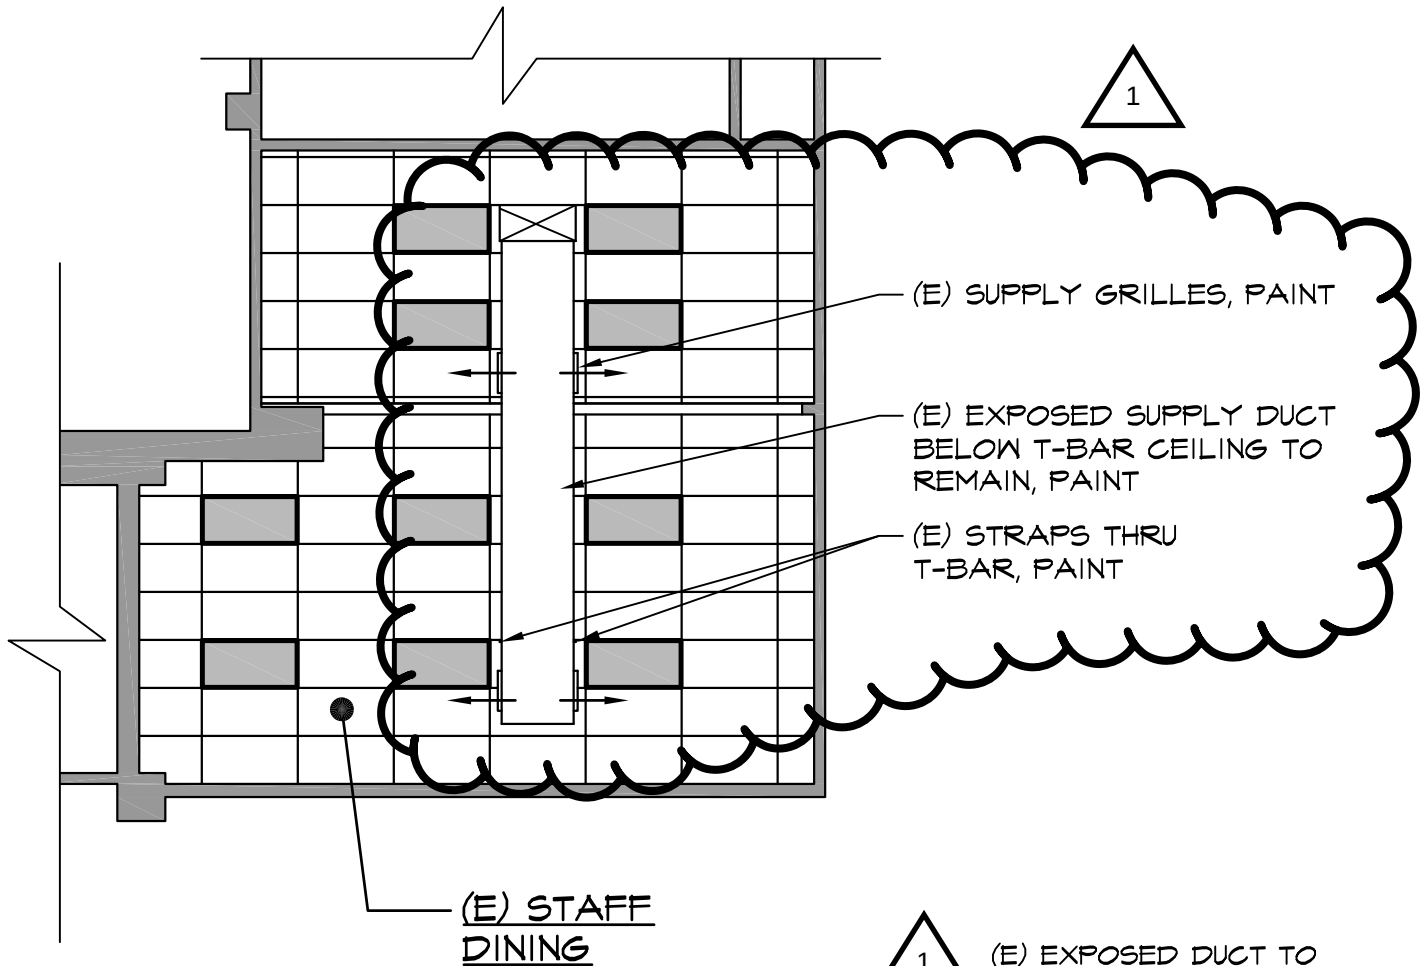
ITEM • 2-20a

1 (E) EXPOSED DUCT TO REMAIN

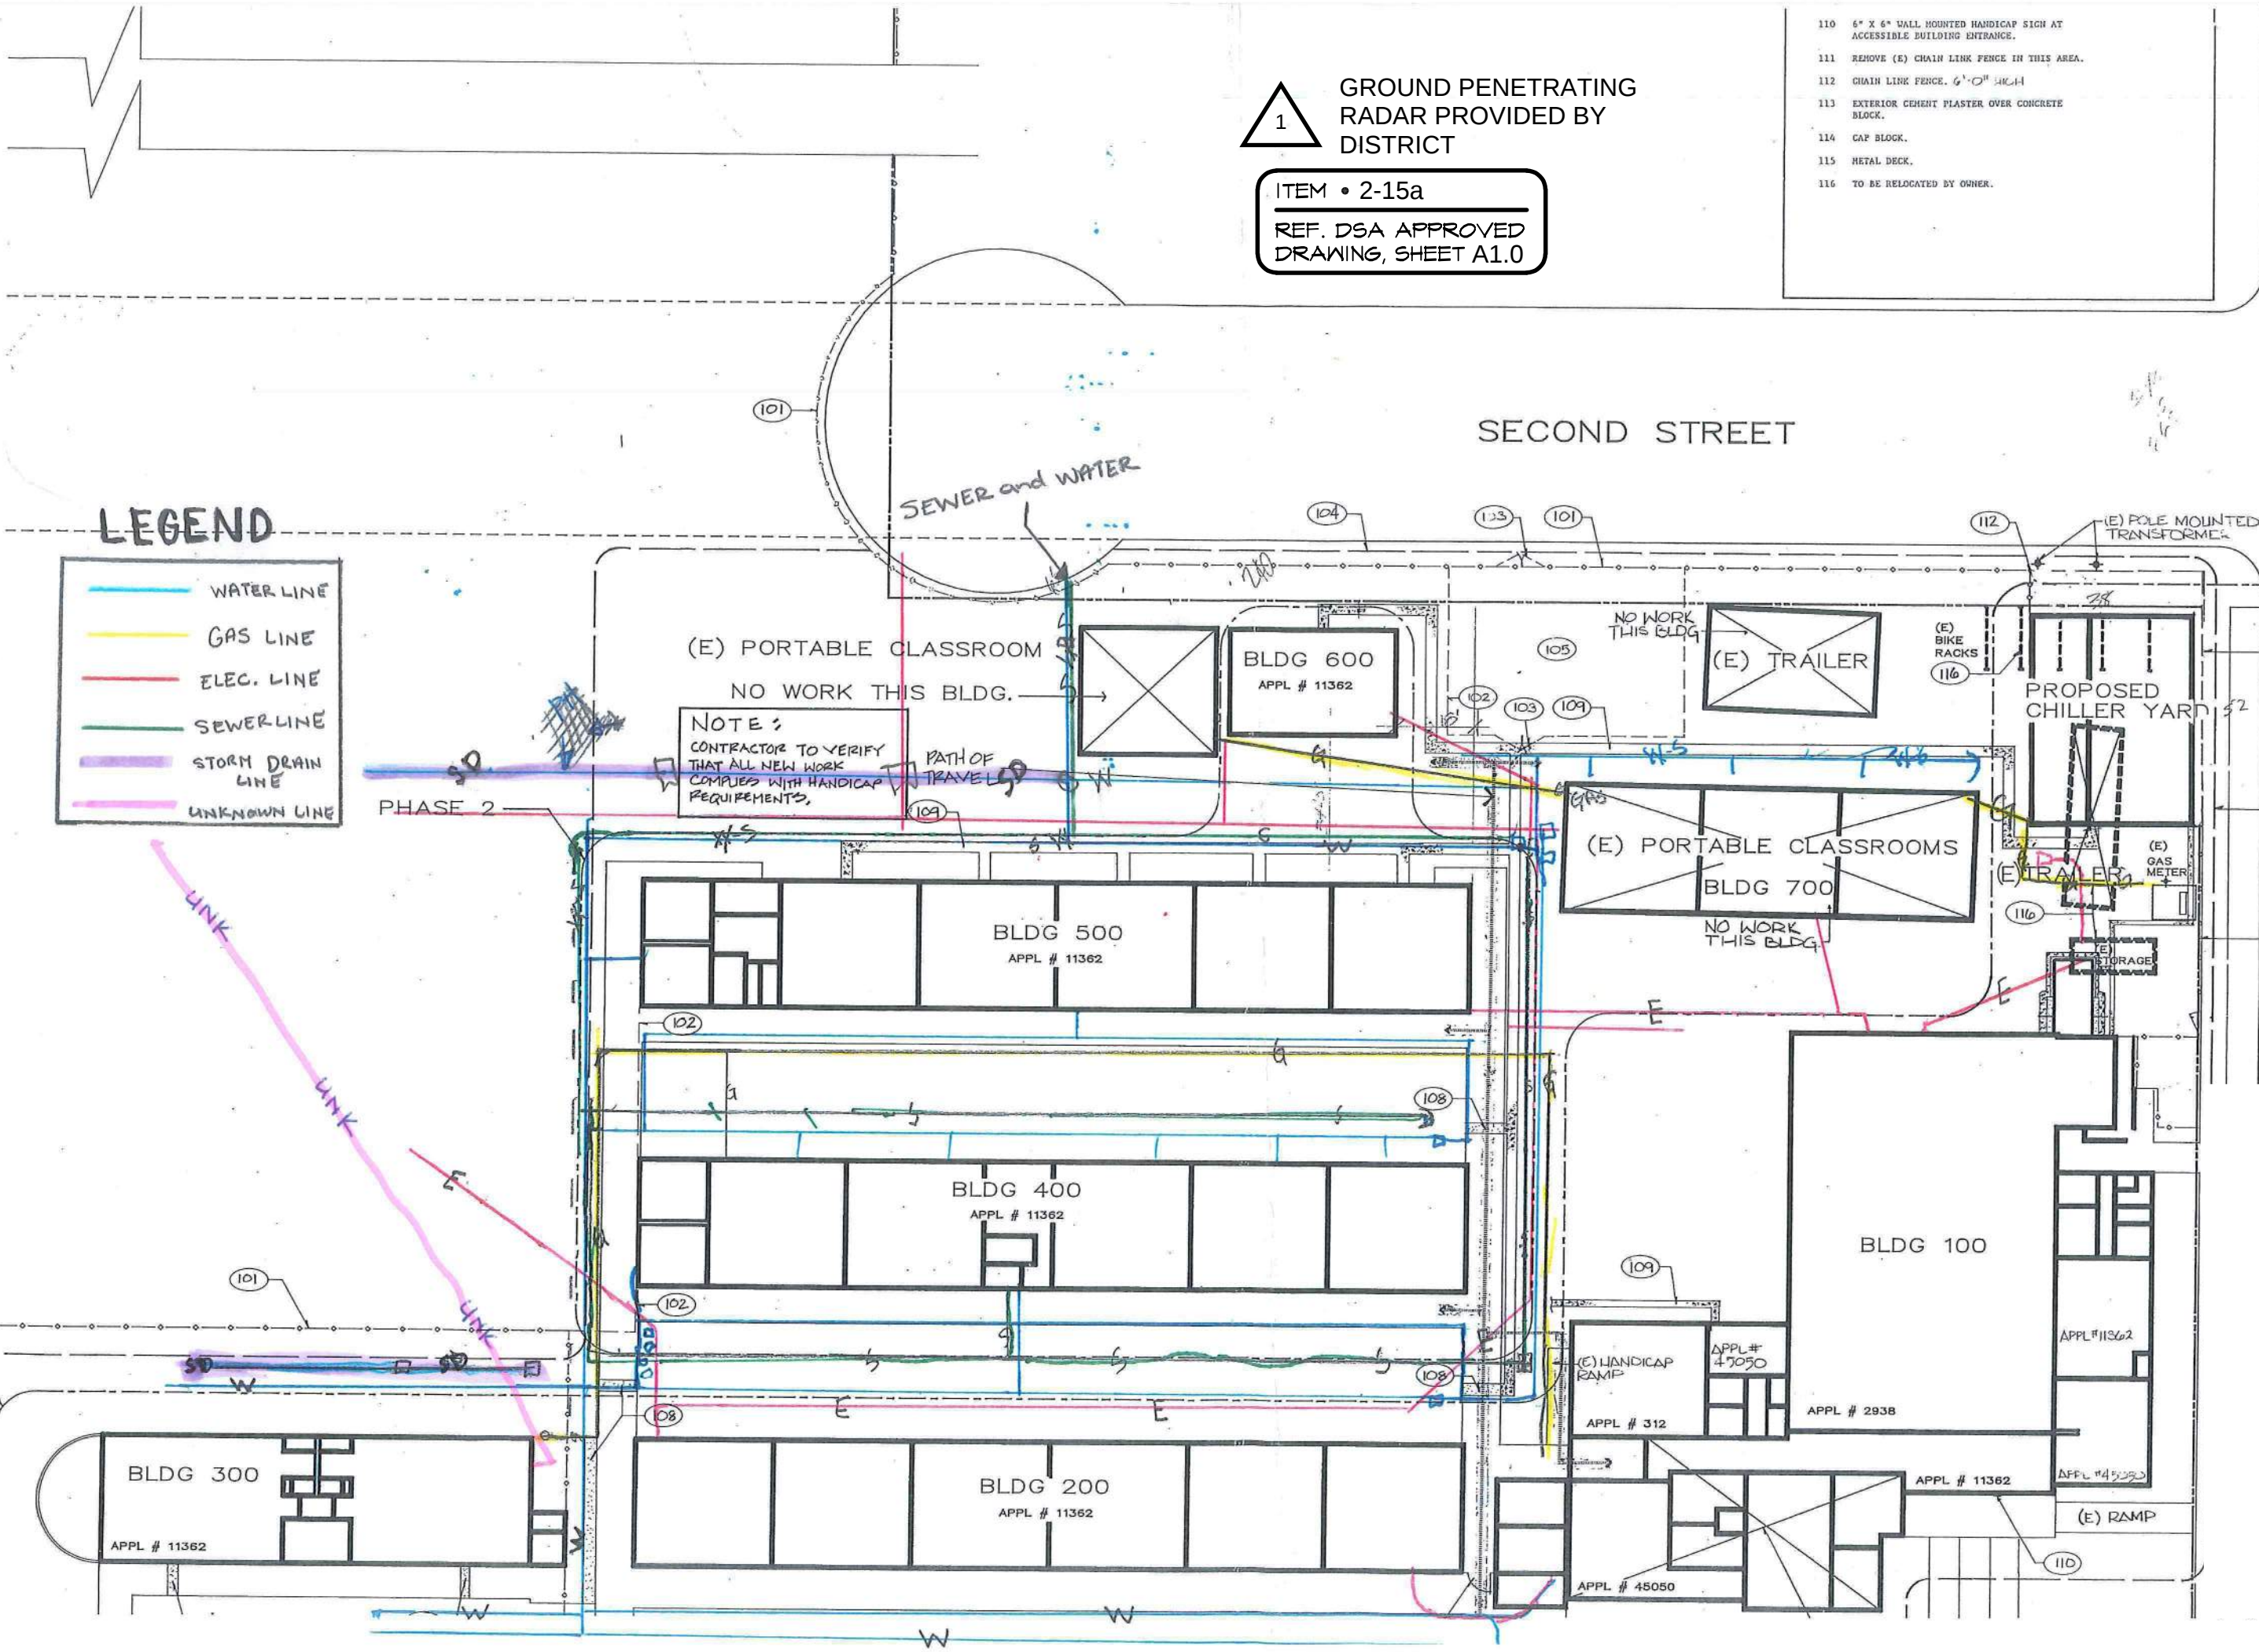
ITEM • 2-15a  
REF. DSA APPROVED  
DRAWING, SHEET A1.0

GROUND PENETRATING  
RADAR PROVIDED BY  
DISTRICT

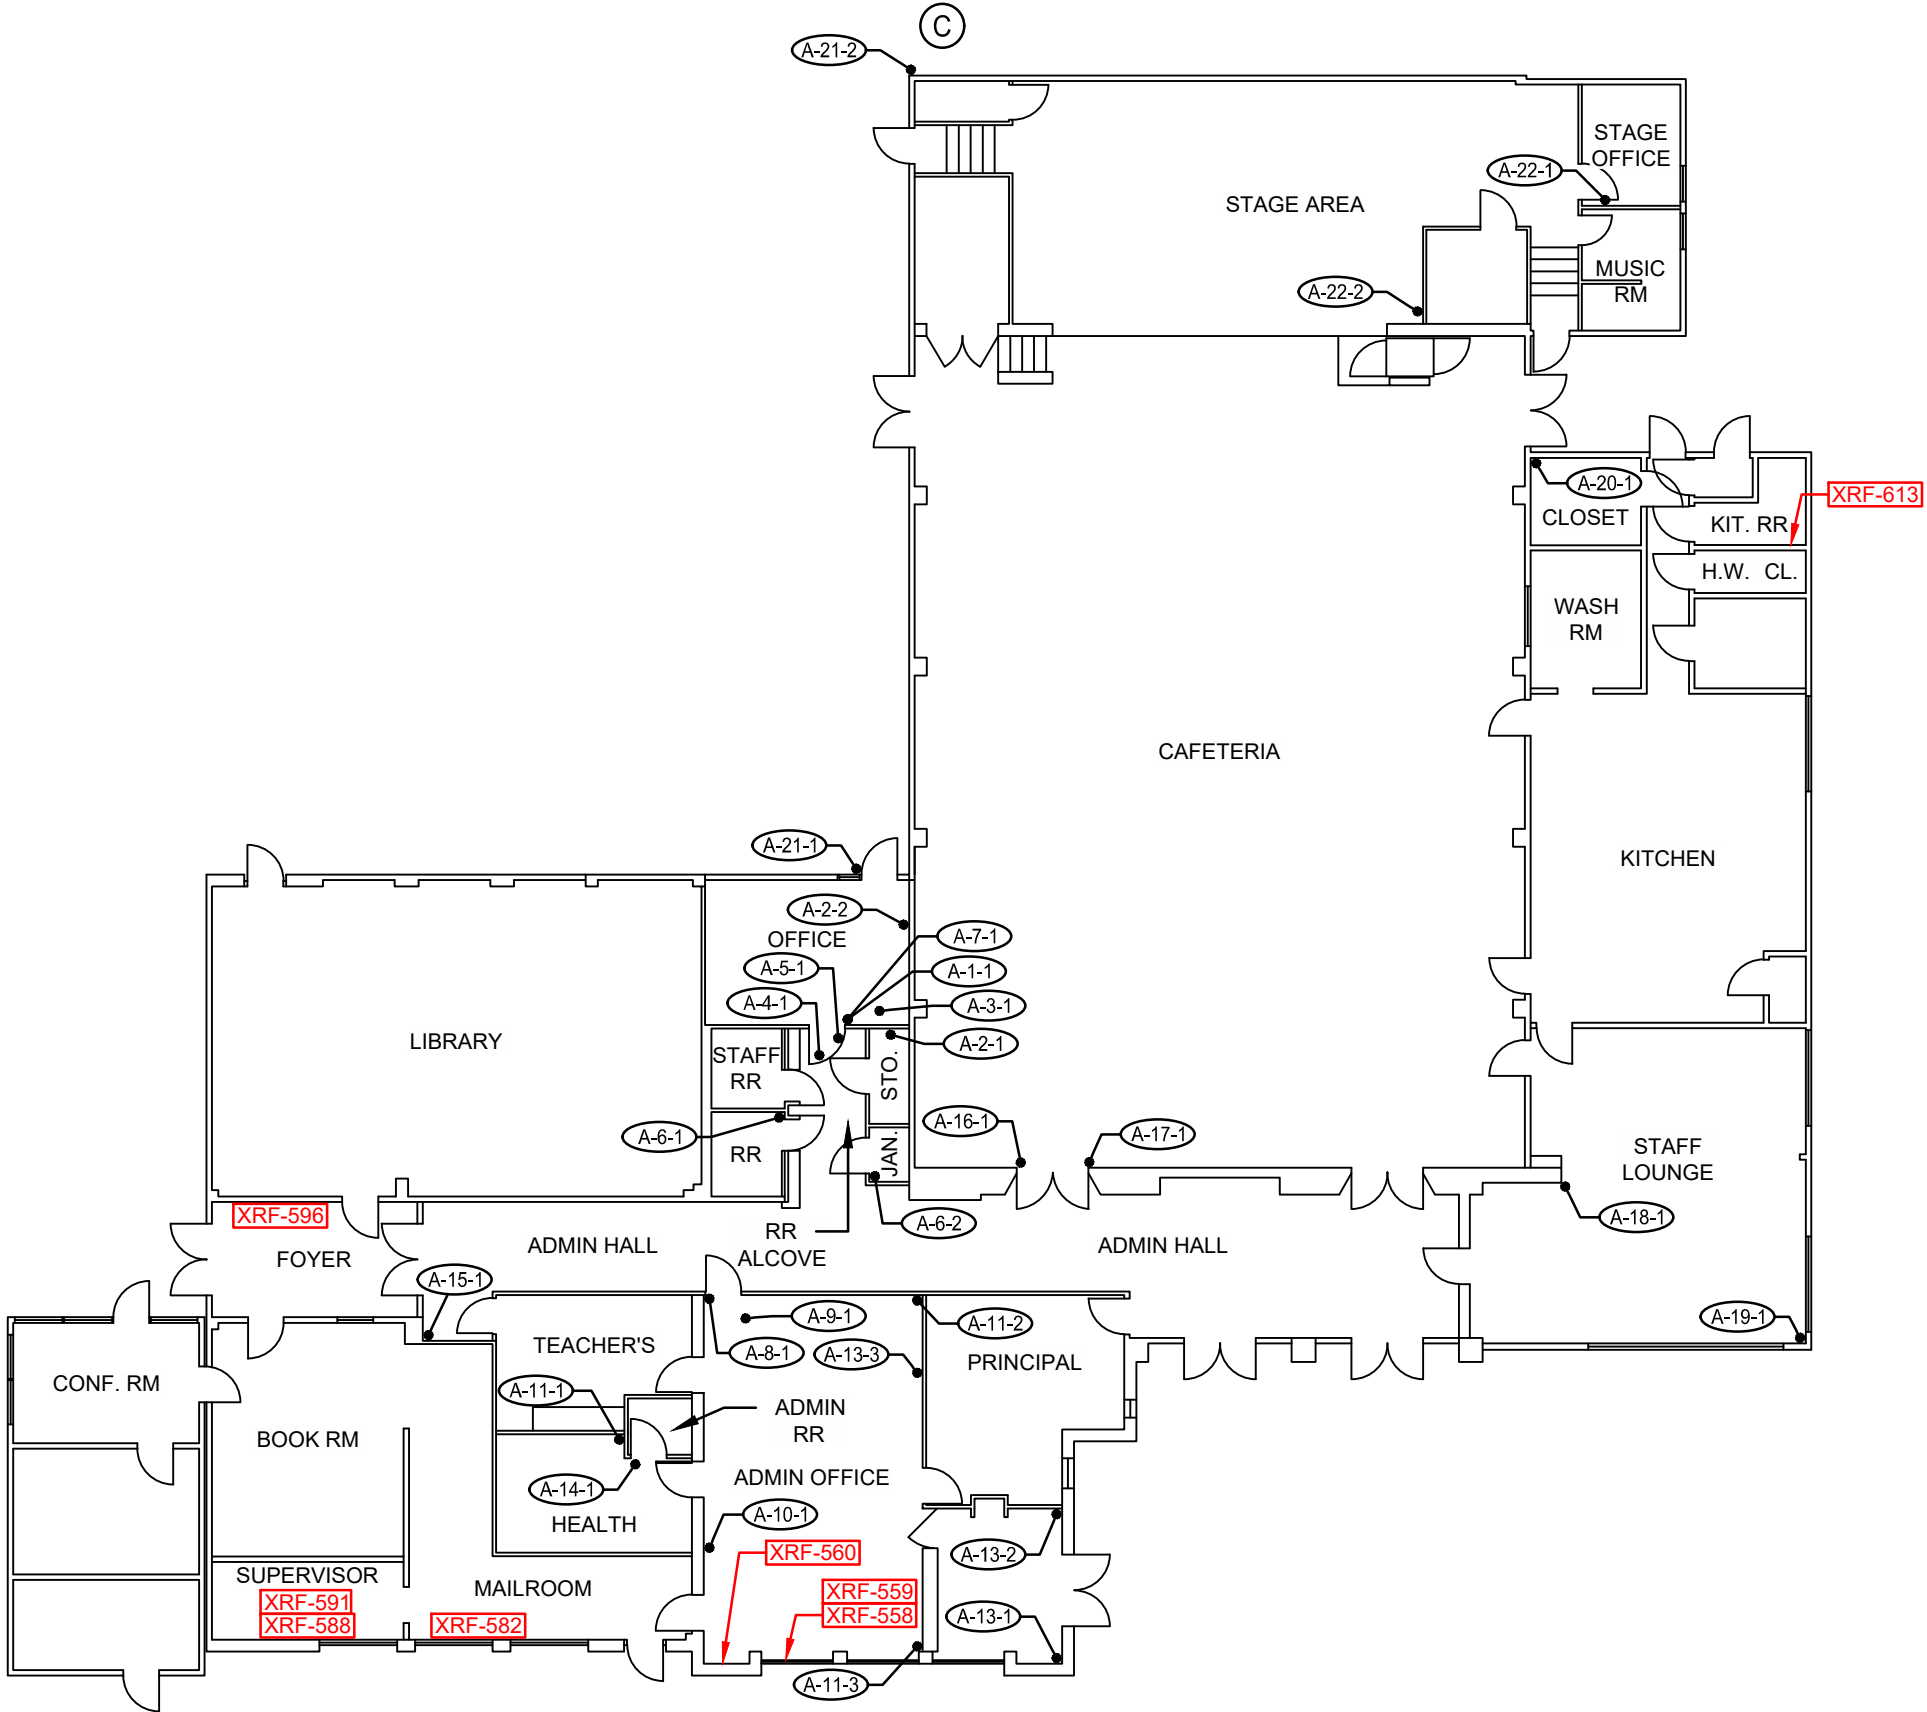
DRAWN BY:  
TREVOR BROOKS  
DATE: 1/17/23 - 1/18/23  
JOB NO: 02854-22-002  
1 OF 9

(A) DENOTES SIDE REFERENCE

XRF-## DENOTES POSITIVE LEAD SAMPLE
